TECHNICAL BULLETIN

MODEL/DERIVATIVE:
MINI

No: 0012
Ref: R0809bu
Issue: 2
Date: 26.07.95

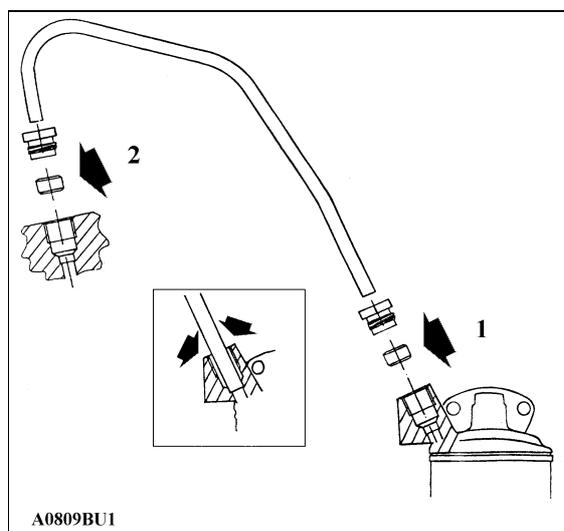
PROBLEM:
OIL LEAK FROM EXTERNAL OIL PIPE CONNECTION - OLIVE

Oil leaking from external oil pipe to cylinder block via tube nut connection.

CAUSE:
Torque relaxation of tube nut

Assemble new pipe part number LQP10033 and original tube nuts with new rubber seal part number LZB10017 to filter end (1 in illustration), and modified aluminium olive part number LZV100080 to cylinder block end, (2 in illustration).

Fit oil pipe to block and oil filter housing, ensure pipe is fully inserted into cavity recesses (see illustration inset), engage tube nut threads and apply "Loctite Lock'N Seal 242" to exposed threads and tighten tube nuts by hand alternating 1/4 turn at a time so as to avoid over stressing pipe in any one direction.

Finally tighten each tube nut with a suitable open ended spanner .

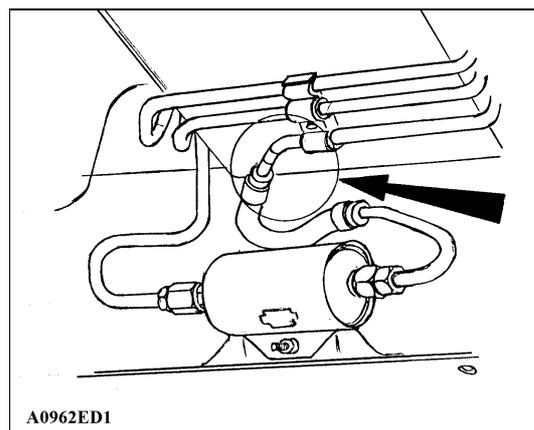
PROBLEM:
ENGINE NON START / FUEL PUMP NOISE - PIPE DAMAGE

CAUSE:
Bent under floor fuel feed pipe particularly in area illustrated. This may result in the flexible fuel feed hose being kinked causing local fuel pressure build-up.

ACTION:
Carefully re-shape fuel feed pipe so that flexible hose returns to correct position.

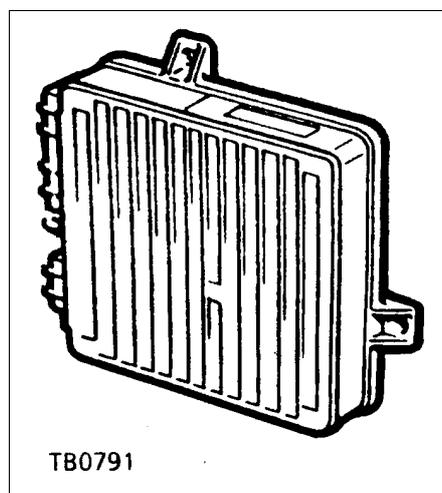
E.C.U. FAILURE - WATER INGRESS

E.C.U. failure, either permanent or for a short period of time.

Water ingress into E.C.U. due to various power wash operations.

The E.C.U. is designed to be splash proof only, therefore it is possible under an extreme power wash situation to force water into the E.C.U. via the casing or drain holes.

Inform all relevant service staff of this possibility and ensure adequate protection for the E.C.U. is provided if a power wash is used in the engine compartment.

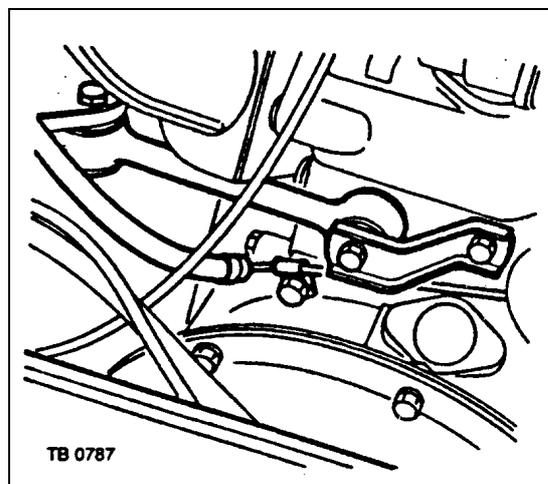
Engine shunt / kick, at light throttle. This condition may appear from approximately 6000 miles (9600 Kilometres) onwards.

CAUSE:
Upper engine steady bar bushes providing insufficient damping

ACTION:
Replace existing bushes with heavy duty bushes.

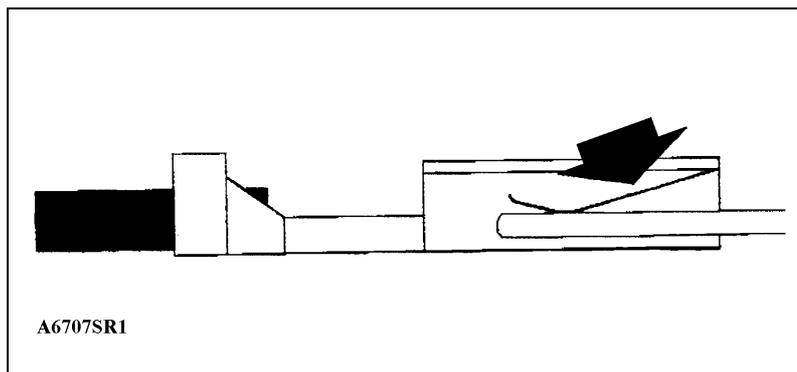
PROBLEM:
ALARM ECU CONNECTOR PINS DAMAGED BY TEST PROBES

Intermittent immobiliser and alarm problems caused by damage to the ECU connector pins, this condition may follow a previous repair where incorrect probes have been used.

CAUSE:
The connector uses 2 sizes of contacts pins, 040 and 070. Incorrect test probes will cause damage to the contact spring leaf (arrowed in illustration) and result in intermittent failure.

ACTION:
The only tools that should be used to probe the connectors on their mating faces are TestBook part numbers DTC0009A or DTC0036A, these contain a male orange probe which can be used for 070 size pins, however there is no probe for size 040 pins.

If size 040 pins require to be probed or if the Testbook tools are unavailable, the only satisfactory way is to snap up the anti-backout flange on either side of the connector and probe from the side where the wires enter.

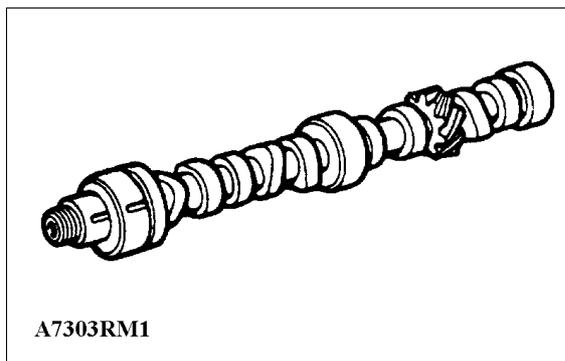
Camshaft reluctor teeth not to specification resulting in irregular cam sensor pick-up. Since the cam sensor only requires synchronising on start-up, it is likely that some starts will not detect an error resulting in normal running for that journey.

Condition described above will be apparent from new even though condition may not occur on every journey. If no other faults are apparent, e.g. ignition or fuel related then replace camshaft. If symptoms develop after a period of time suspect causes other than cam reluctor.

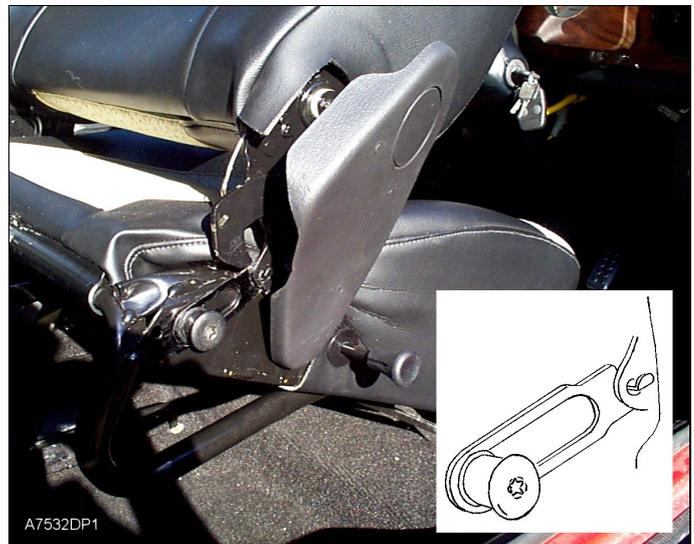
CAUSE:
Unrestrained squab tipping resulting in hinge escutcheon fouling cushion cover.

ACTION:
The damaged seat cushion cover(s) will require replacement.
To prevent re-occurrence of seat cover damage, fit two check straps per seat part number HZU 100050.
This modification should be applied to both front seats even if opposite seat has not sustained damage requiring cover replacement.
All vehicles from Vin 151917 onwards have check straps fitted.

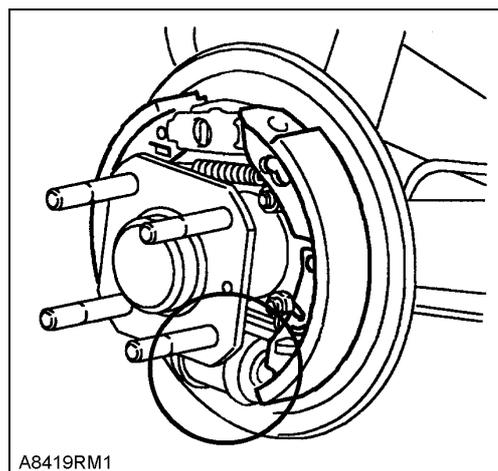
CAUSE:
Incorrect diagnosis. In the majority of instances, fluid seen around a wheel cylinder boot is assembly fluid. Assembly fluid is used by the wheel cylinder manufacturer to assist the piston to cylinder assembly process. If excess amounts are used inadvertently, fluid may be forced past the cylinder boot and become visible.

ACTION:
DO NOT replace brake wheel cylinder if fluid signs are isolated to cylinder boot only and are showing no additional brake fluid loss or lining contamination signs.
