TECHNICAL BULLETIN

MODEL/DERIVATIVE:
MINI

No: 0012
Ref: R0809bu
Issue: 2
Date: 26.07.95

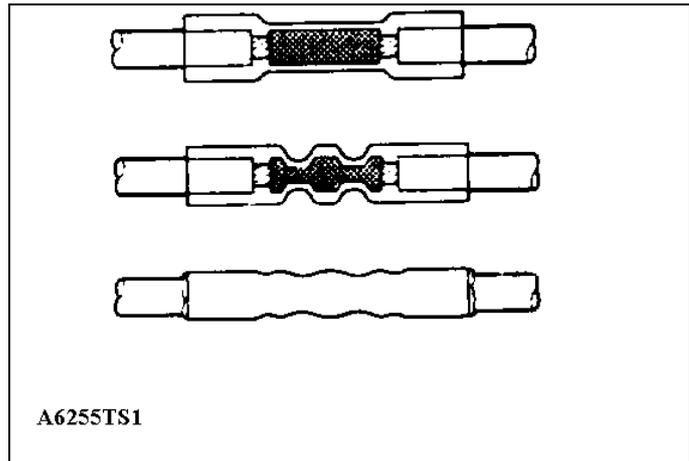
Wiring or electrical component failure following previous wiring rectification.

Unsuitable wiring connectors used for wiring repair resulting in subsequent failure in service.

In the event of wiring rectification being required or where such action cannot be carried out by replacement of the existing type of connector, then it is permissible to use 'Crimp and Heatseal' type connectors supplied to Rover by Duraseal.

- 1). Strip wires 7.5mm and insert into crimp barrel of the correct Duraseal size (see below).
- 2). match the colour of the splice and the colour of the crimp cavity on the crimping tool.
- 3). Crimp.
- 4). Heat crimping splice with heat gun until tubing recovers and adhesive melts and flows.

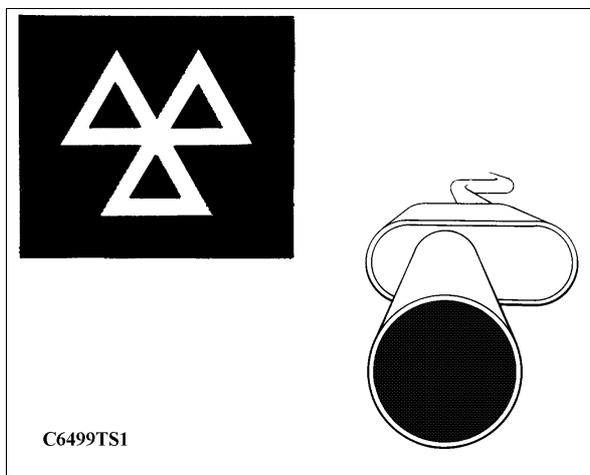
EXHAUST EMISSIONS FAILURE, VARIOUS - due to any of following:-

CAUSE:

Any of the following:-

- Exhaust leak.
- Rich mixture.
- Rich mixture with misfire.
- Weak mixture.
- Oxygen sensor inoperative.
- Catalyst fault.
- Miscellaneous MEMS system faults.

Following emissions test failure, the car should be re-checked in accordance with the top row of boxes on the poster and the readings recorded. The boxes include Rovers recommended readings. Having established which readings are outside recommended values, the 'Result' boxes on the lower part of the poster should be applied along with rectification advice suggested later in this bulletin, see 'Result Action' section.

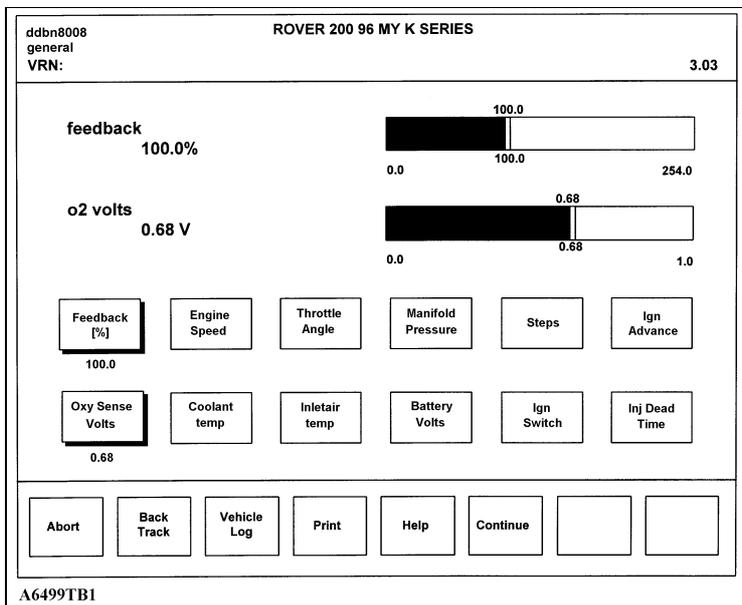
Feedback - Display of feedback fuelling correction. This is shown as a percentage of the mapped (open loop) value. Percentage is continuously updated by the MEMS ECM whenever the conditions for closed loop fuelling are present.

High values of feedback (e.g. above 100%) indicate that feedback is attempting to compensate for fuelling being too lean. Lean values (e.g. below 100%) indicate fuelling being too rich.

Note: Misfire condition will be shown as high values as feedback will be fooled into compensating for a system running too lean.

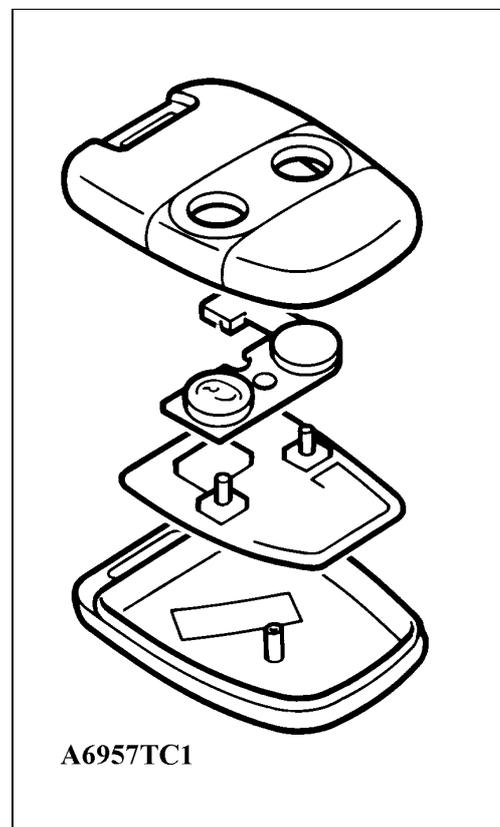
REMOTE HANDSET, BUTTON DAMAGE

Buttons split (damage by finger nail).

Remote handset service kit, part number YWX101010 introduced to enable button and casing replacement whilst retaining the original transmitter component. This improved housing is supplied with modified rubber buttons to prevent reoccurrence of the above problems.

Replacement procedure:

- Prise original handset apart, with a small screwdriver, inserted into the cut-out at the rear (key ring end) of the remote handset.
- Using finger pressure only, prise apart the two clips holding the printed circuit board and remove it from the remote handset.

Note: Handle printed circuit board by its edges only, therefore avoiding any form of contamination to electrical components.

- **Press the new button moulding into the new upper casing.**
- **Clip the original printed circuit board into the new upper housing assembly taking care to align it correctly.**

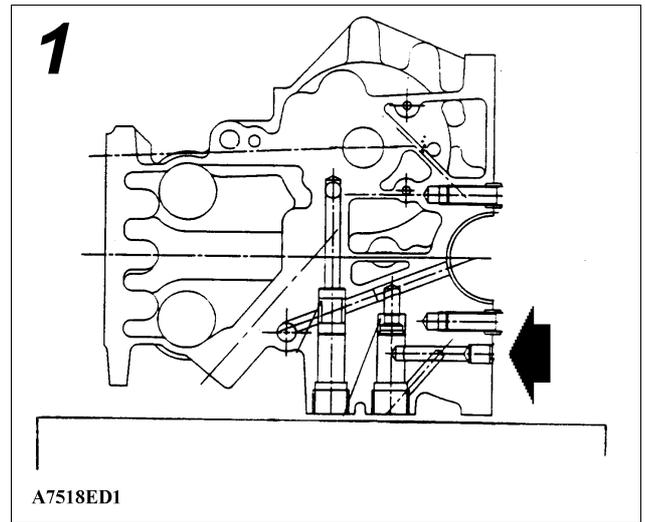
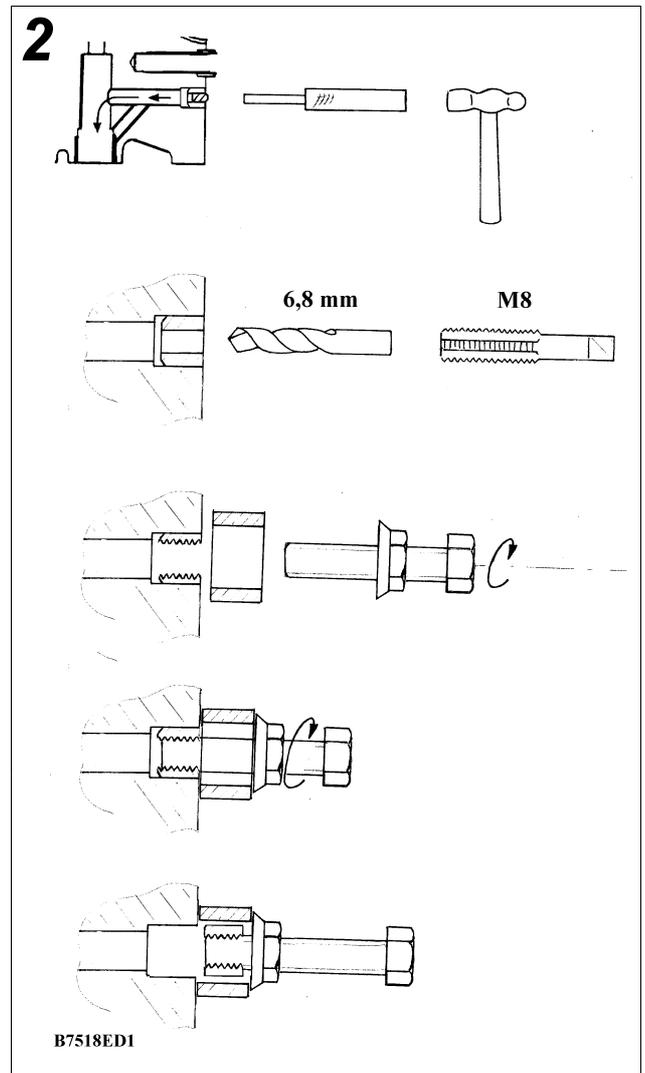
OIL LEAK FROM PRIMARY DRIVE GEAR - GALLERY PLUG

Oil leaking from the end cover to flywheel housing joint or starter motor flanges/bolts.

Sealing Plug Removal Procedure:
Referring to illustration 1 and 2

- Locate the oil sealing plug (arrowed in illustration 1) situated adjacent to the rear main bearing cap. The plug outer is aluminium and the centre core made from steel.
- Using a suitable flat ended punch (illustration 2), gently tap the steel core of the plug until level with the aluminium plug body.

- Using a smaller punch (3 mm dia), tap the plug centre core completely through, it should drop clear from the relief valve hole and onto the bench, if it doesn't, lift the engine slightly and retrieve with a magnet.

- Drill out plug with a 6.8 mm drill and tap hole with an M8 tap, load both with grease to reduce swarf contamination.
- Assemble an M8 nut bolt and washer/spacer and extract the remainder of the plug by tightening the nut against the spacer.
- Clean the surrounding area of swarf and flush out the relief valve hole.

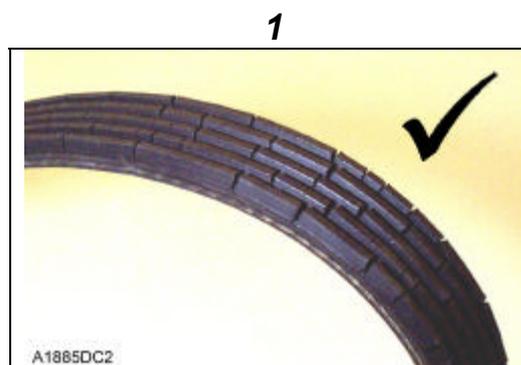
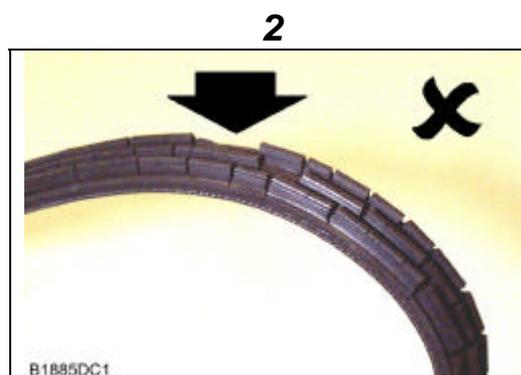
- **Illustration 1** shows a belt with typical rib cracking which must be regarded as acceptable.
- **Illustration 2** shows a belt with abnormal degradation, e.g. portions of ribs missing. A belt in this condition must be replaced.

Conclusion: No action should be taken providing ribs are still intact, i.e. they have no loose or missing portions.

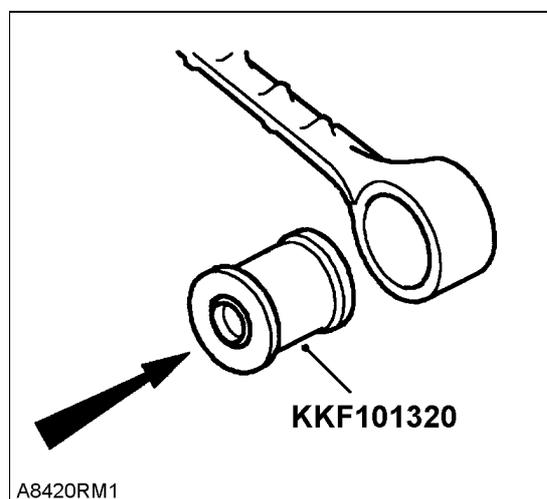
Engine shunt / kick, at light throttle. This condition may appear from approximately 6000 miles (9600 Kilometres) onwards.

CAUSE:
Upper engine steady bar bushes providing insufficient damping

ACTION:
Replace existing bushes with heavy duty bushes.

2. Press new single bush KKF101320 complete with bonded internal spacer tube into engine steady. To assist fitment, the new single bush assembly can be pushed into steady with the help of a vice and a suitable spacing tube such as a socket, (there is no special tool available for this purpose).

3. Refit upper engine steady to vehicle.
